Seeing Redds: Aerial Photo Redd Surveys as a Snapshot of Restoration Results in the Lower American River

Katherine Perkins, Sacramento Water Forum; Lilly Allen, Sacramento Water Forum; John Hannon, Bureau of Reclamation Bay-Delta Office; Ian Smith, Bureau of Reclamation Bay-Delta Office

Sharing a Salmon Spawning Success Story: Restoration and Redds at Upper Sailor Bar

Restore, Monitor, Repeat: Lower American River Anadromous Fish Habitat Restoration Project

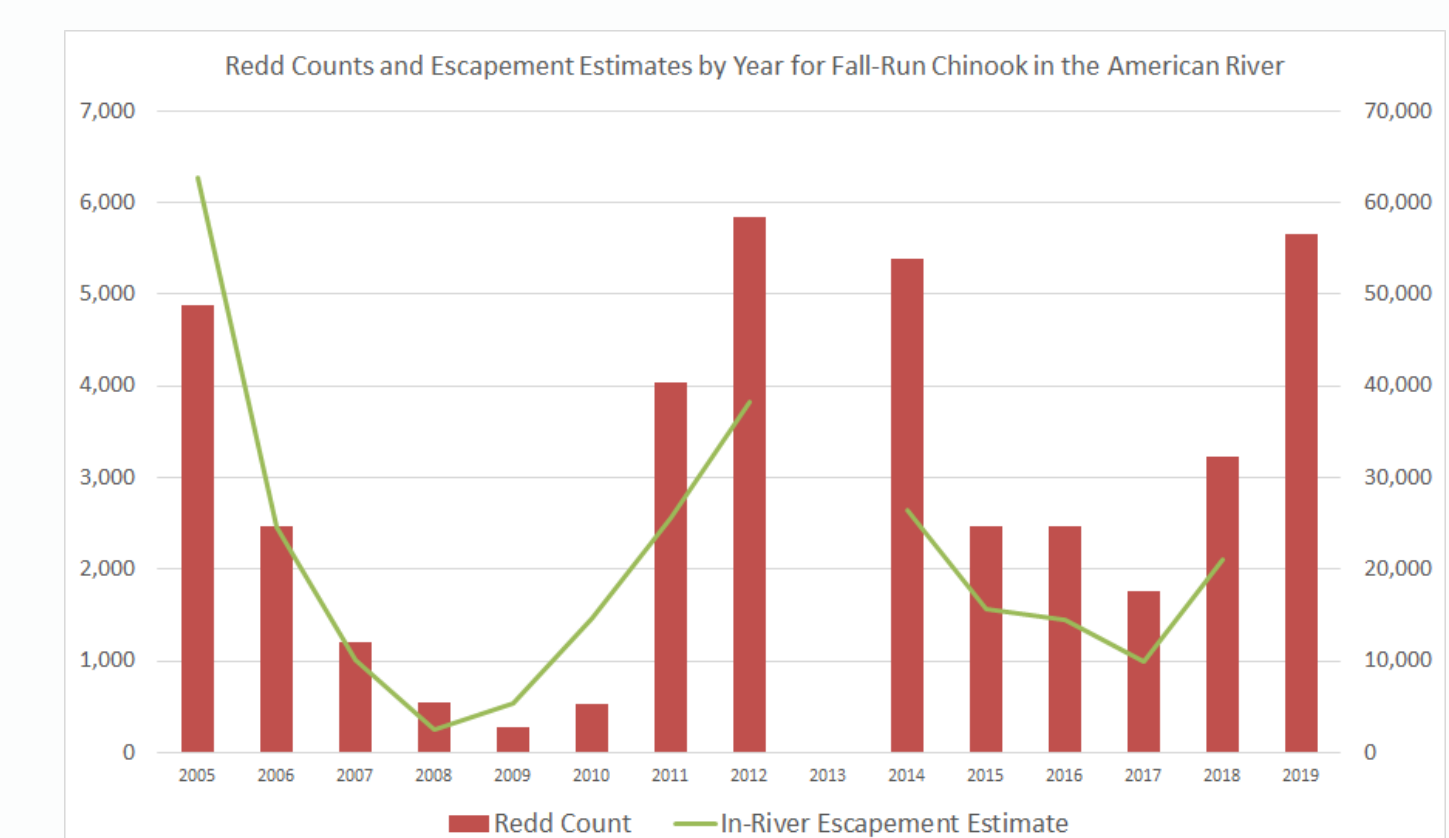
While there are challenges to aerial redd survey accuracy, aerial photo redd count data on the lower American River has tracked relatively well with escapement estimates - indicating it is an effective indication of the magnitude and distribution salmon spawning activity.

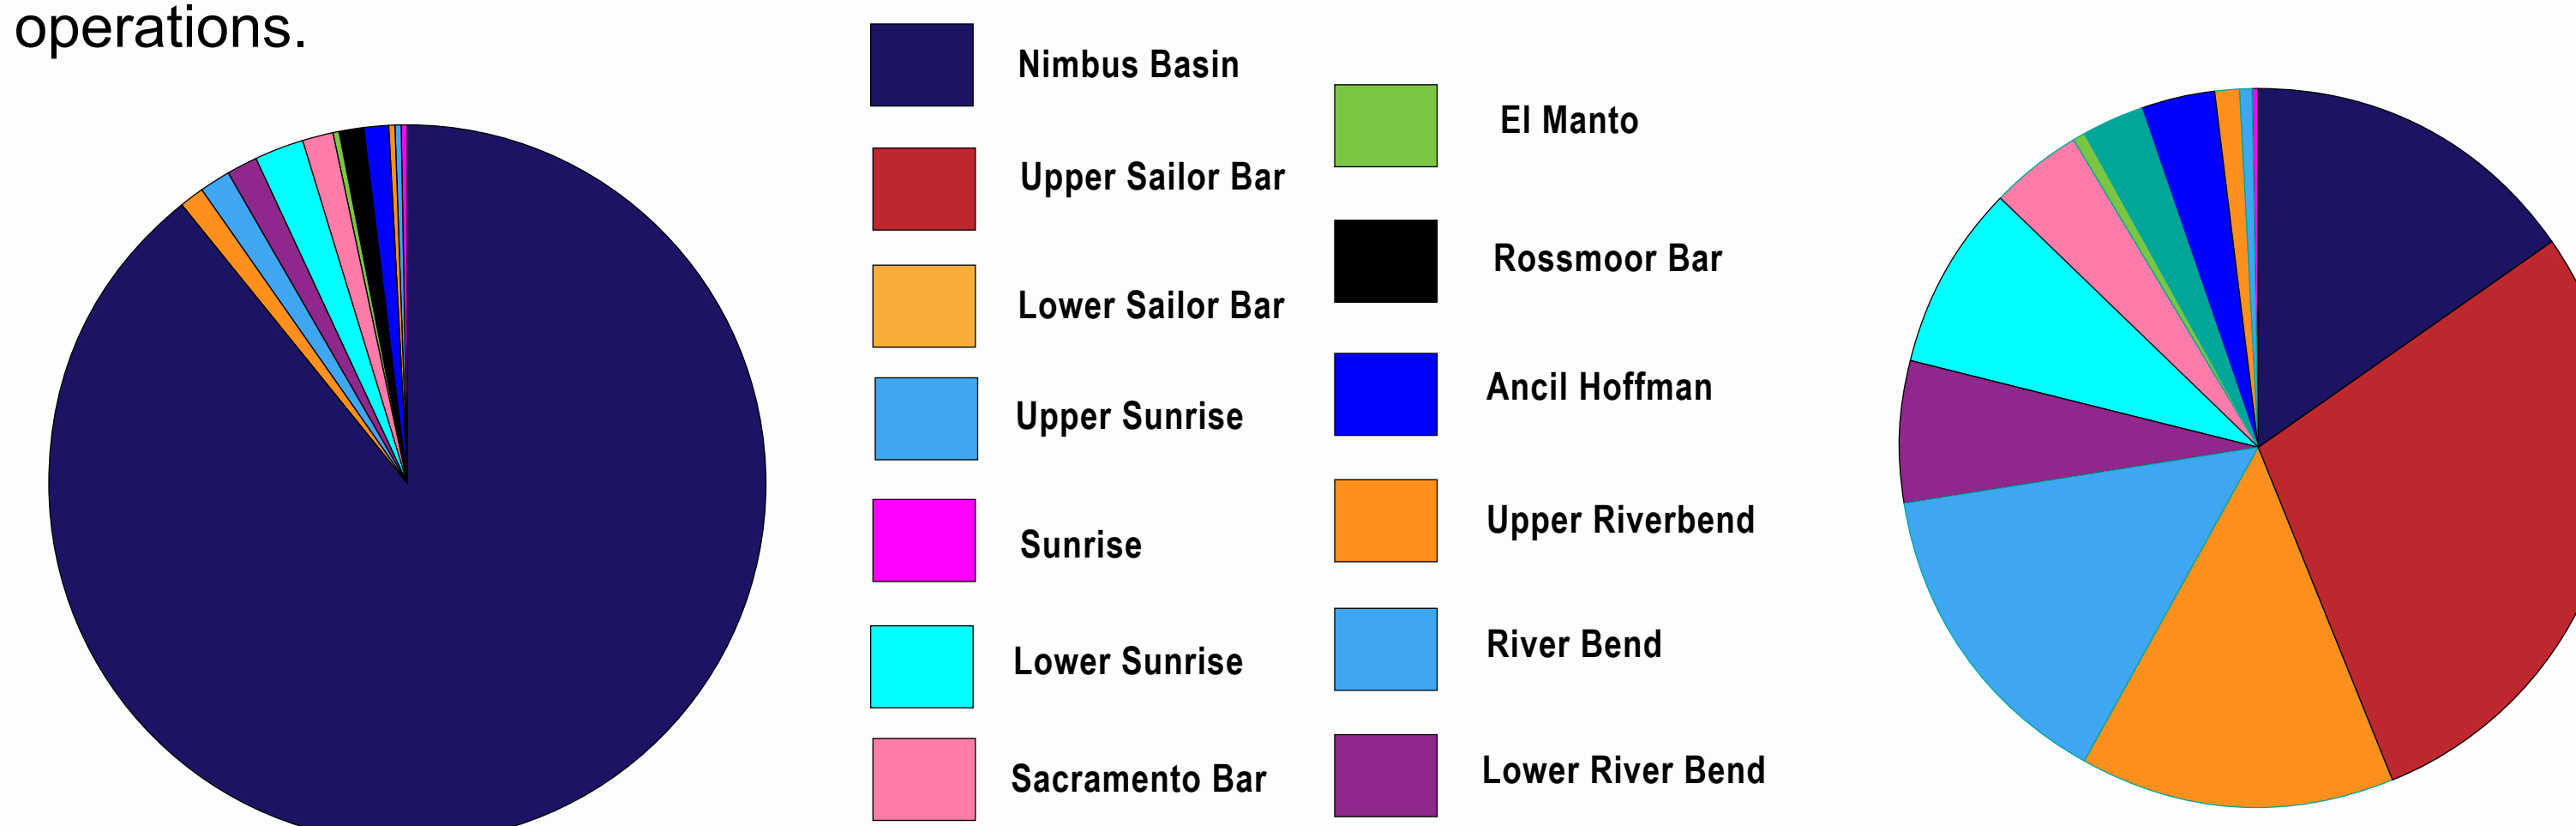
Riverwide Redd Distribution: 2018 vs. 2019

Aerial redd surveys provide a snapshot of spawning throughout the river. Looking at the change in the proportion of redds at Upper Sailor Bar, it's clear that restoration activity at the site effectively increased habitat availability and use by Chinook salmon. **Redd counts at the site increased from 0% percent of spawning activity river-wide in 2018 to 28.6% percent in 2019.** While our agencies are only able to implement a restoration project at one or two sites each year logistically, we must consider the river at a whole system. In the lower American, a river in which salmonid spawning (and especially rearing) habitat is severely limited and superimposition of redds is common, we hope that an increase in habitat availability at one site takes pressure off other, existing habitat. Unfortunately, we observed a high amount of superimposition in Nimbus Basin again during the 2019 Chinook salmon spawning season due to wier operations.

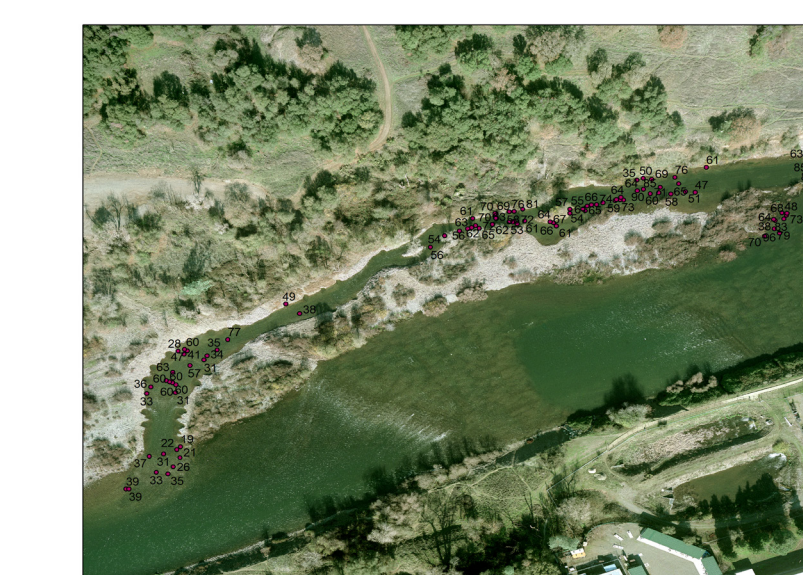
The most recent restoration project at Upper Sailor Bar is a great example of adaptive management on the lower American River: this area just below Nimbus basin was restored over ten years ago and the gravel placed there had naturally been mobilized by high flows. Aerial survey data showed a clear decrease in spawning activity at the site. Post-restoration, spawning activity increased from nearly no spawning activity the previous year to over sixteen-hundred redds counted at the site in 2019. In addition to aerial photographs, we documented the locations, areas, velocities, and depths of redds at the site with on-the-ground surveys. This redd survey data informed dam operators' decisions about how best to manage flows in order to minimize redd dewatering while preserving as sizable of a cold water pool as possible in a dry year. The graphic below was provided as part of documentation on redd surveys to the American River Group, a multi-agency advisory body which provides input on operations of Folsom dam.
